**New York State Energy Research and Development Authority**

**ENERGY USE ASSESSMENT**

HIGH RISE APARTMENT BUILDING  
UPPER WEST SIDE, NYC

Audit Visit Date: 30 November 2006

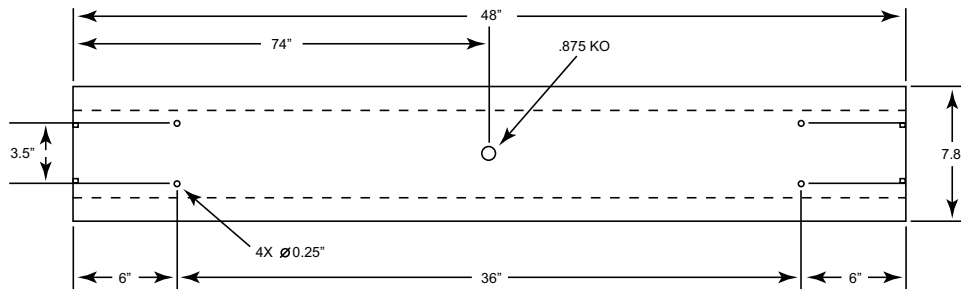
### cross sections

- A unique bi-level luminaire controlled by an integral ultra-sonic motion sensor, designed to provide safe, dependable illumination while conserving energy. Suitable for ceiling or wall mounting

- One-piece extruded linear ribbed clear, light stabilized acrylic is standard, 100% DR acrylic available
- Features a linear refractive pattern for even illumination
- Grooved formation on the edges allow for a tight, no light leak attachment to the body
- Optional white powder coated perforated steel diffuser

Second, replace the forty-two stairway fixtures with utilitarian fixtures equipped with ultrasonic occupancy sensors, providing 2000 lumens on the “high” setting and ensuring four foot candles

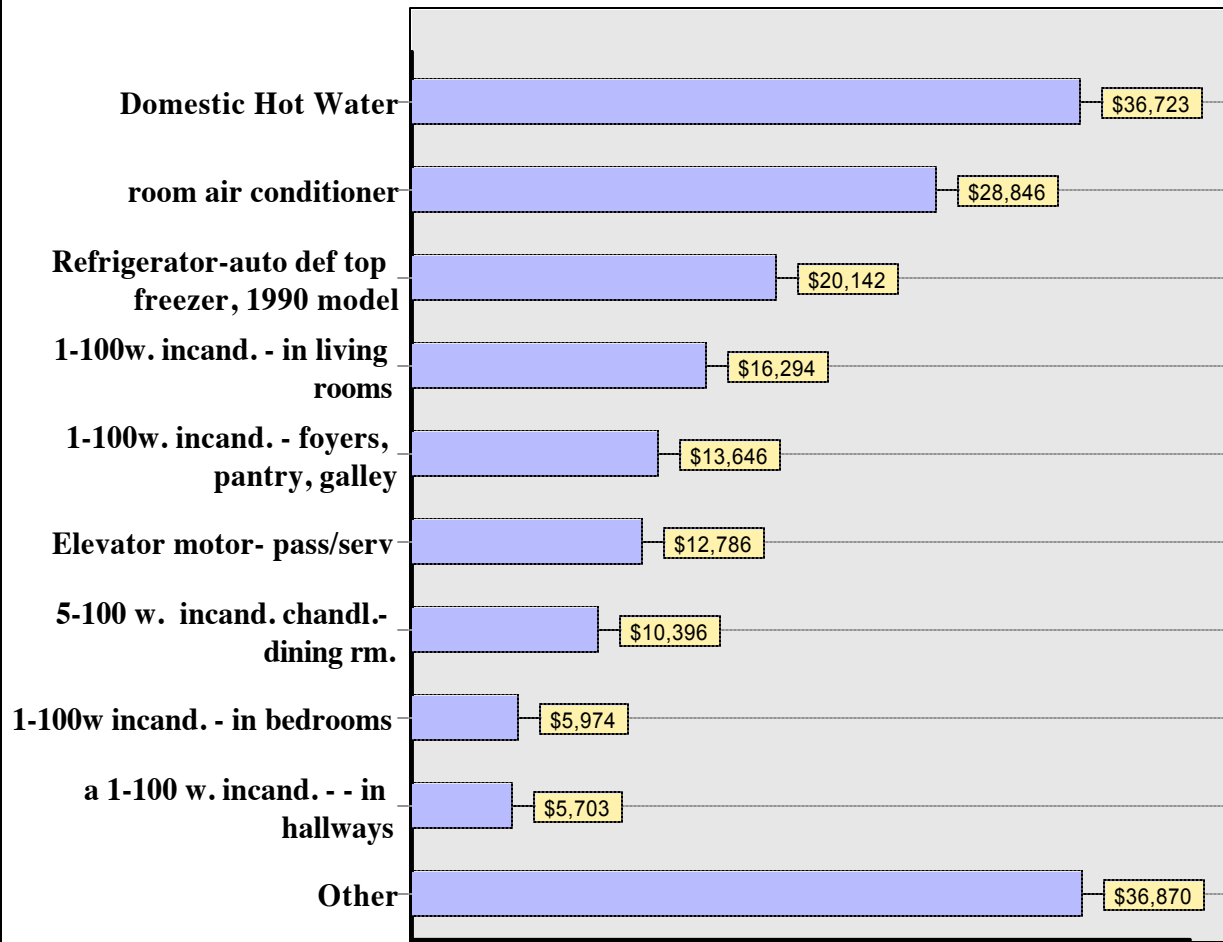
# Base Load Energy Users

Total
							\$
1. Domestic Hot Water							36,723
2. room air conditioner							28,846
3. Refrigerator-auto def top freezer, 1990							20,142
4. 1-100w. incand. - in living rooms							16,294
5. 1-100w. incand. - foyers, pantry, galley							13,646
6. Elevator motor-pass/serv							12,786
7. 5-100 w. incand. chandl.- dining rm.							10,396
8. 1-100w incand. - in bedrooms							5,974
9. a 1-100 w. incand. - - in hallways							5,703
10. Other							36,870
<b>TOTAL</b>							187,380
